Check Out

123 Sample Street
Sample City
Sampleshire
AB1 2CD

March 29th 2021

Clerky Clerk

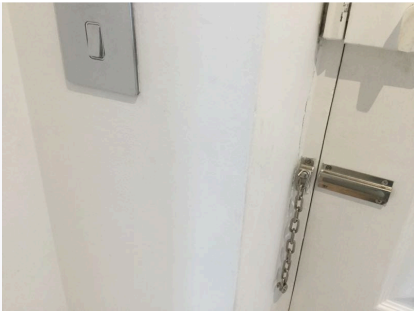
Ref # 2.3

2.3	Walls	White painted	Number of touch up marks are visible to the paintwork; A few further minor finger marks scattered in places; Especially evident to the right wall on entry; Marks consistent with the length of the tenancy; Fair Wear and Tear

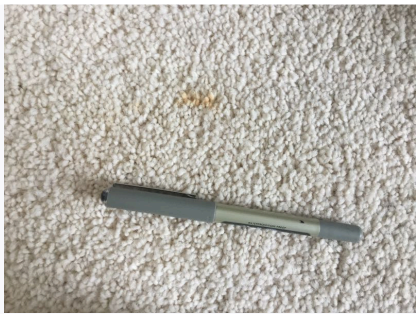
Ref # 3.4

3.3	Threshold	Solid light wooden threshold	Intact; Very lightly scuffed with use;	
3.4	Flooring	Beige fitted carpet	Minor discolouration visible to the edges; Quite flattened on entry with use and age; Number of very faint residue marks remaining; Minor furniture indentation marks are present; There is an additional 2cm light brown stain present to the left hand side of the room that did not come out during the professional clean of the property; Some further treatment may be required; Comment - Tenant

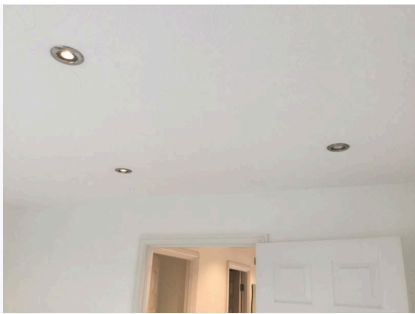
Ref # 3.8

3.7	Ceiling	White painted with textured finish	In good condition;	
3.8	Lighting	8 x Ceiling mounted spotlights with chromed trim	1 x light bulb has expired; Needs Replacing - Tenant

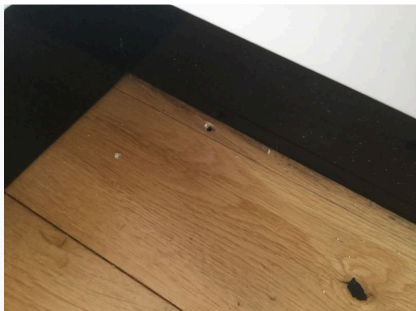
Ref # 9.1

Ref	Name	Description	Condition	Additional Comments
9.1	Flooring	Solid oak floorboards	<p>Many of the floorboards are slightly moving apart and lots of gaps are visible throughout; Lightly scuffed and scratched on entry; Flooring appears to be slightly raising in front of the washing machine; Further light scuffs to the centre; One of the floorboard is cracked to the middle in front of the 3 x large drawers;</p> <p>There is an additional small drilled hole to the far left corner of the floor; Needs Maintenance - Tenant</p>

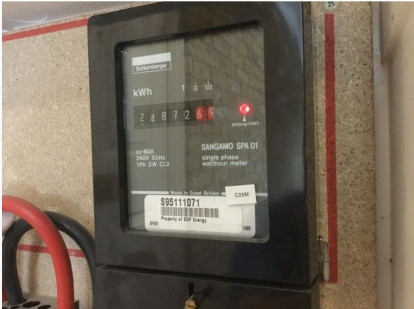
Ref # 11.1

Ref	Name	Description	Condition	Additional Comments
11.1	Electric Meter	Cabinet near flat door; Serial Number: S95111071	24872;	
11.2	Gas Meter	Front Of building; First hatch to the left of the building main doors; Covered by a large bush; Serial Number: 5036928S	4584;	
11.3	Water Meter	2 X hatches present to the front left of the building main doors; Meter located in the right hatch; Serial Number: 16MU060785	Appears to read 0028 but very difficult to read as the top cover is obscuring the display;

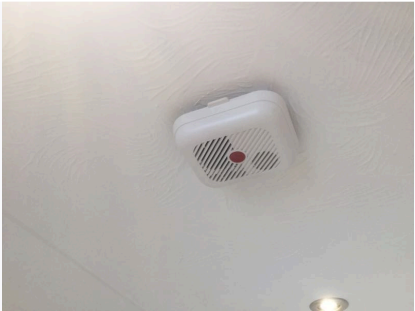
Ref # 13.1

Ref	Name	Condition	Additional Comments
13.1	Hallway	Tested and working;	
13.2	Hallway	Not in use;
