Check Out

123 Sample Street
Sample City
Sampleshire
AB1 2CD

March 29th 2021

Clerky Clerk

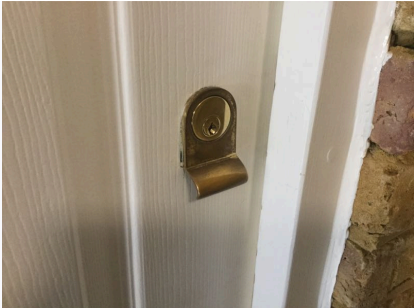
<p>Ref # 1.5</p></div></div>

1.5	Front Door Exterior	White painted panelled wooden door; Brass numeral '50'; Brass spyhole with glass cover; Brass union lock with fingerplate; Brass letterbox and flaps; Further lower level silver E*S lock with a brass surround	All of the metal is quite scratched and tarnished with age, but intact; Lower lock is new; Letterbox is quite scratched to either side, but intact; Woodwork is in good order; Locks are in working order; The agency has informed SRP Inventories that the top lock was replaced by the landlord during the tenancy as it was faulty; Comment

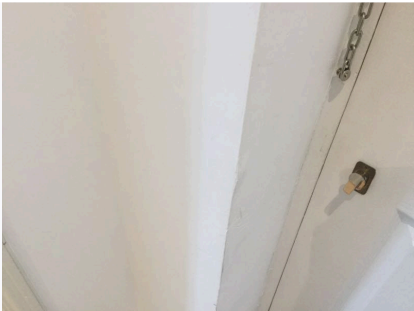
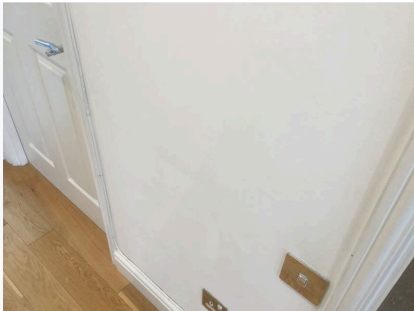
Ref # 2.3

2.3	Walls	White painted	Number of touch up marks are visible to the paintwork; A few further minor finger marks scattered in places; Especially evident to the right wall on entry; Marks consistent with the length of the tenancy; Fair Wear and Tear

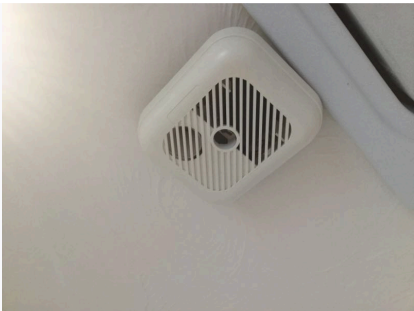
Ref # 2.7

2.6	Lighting	4 x Ceiling mounted chromed spotlights	All are tested and working; Some of the paintwork is slightly chipped around the fittings;	
2.7	Smoke Alarm 1	1 x Ceiling mounted white plastic battery powered smoke alarm	The testing button is missing and appears to have been removed; Needs Replacing - Tenant

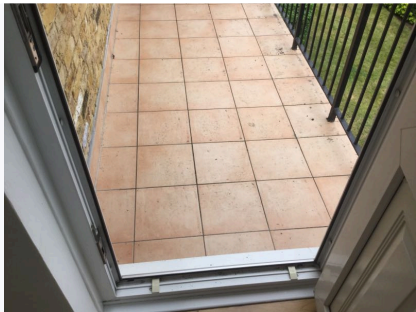
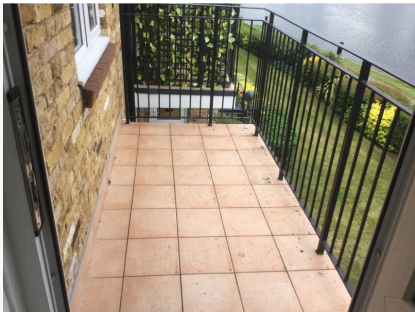
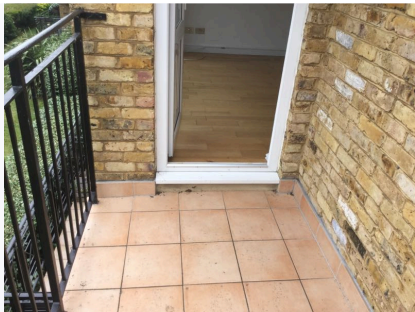
Ref #8

Ref	Name	Description	Condition	Additional Comments
8.1	Flooring	Peach coloured ceramic tiles	2 x Large brown residue spots seen to the rear, otherwise in good condition; Scattered cobwebs and dust throughout; In outdoor condition; Painted over paint flaking as visible;	
8.2	Walls	Bricked walls	Worn consistent with age; In good condition; No major damage visible;	
8.3	Gutters and Roofing	Black and white plastic gutters with slat tiles above	No major damage visible; Worn consistent with age;	
8.4	Railings	Black painted metal railings	Painted over paint flaking as visible; No major damage seen; Lots of cobwebs present throughout;

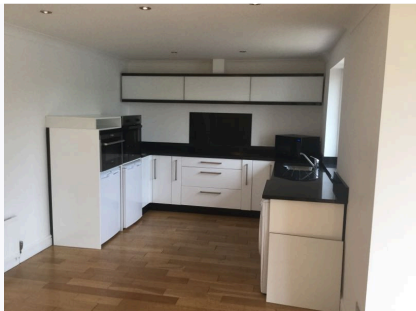
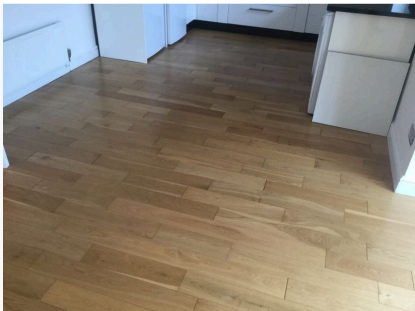
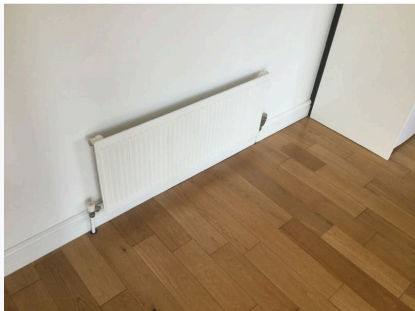
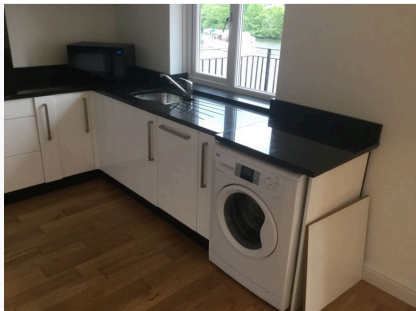
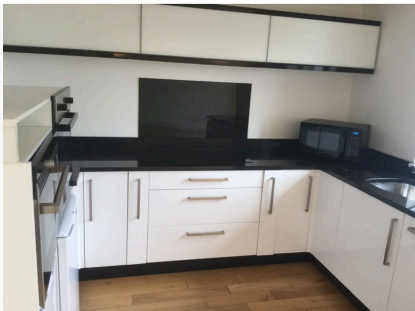
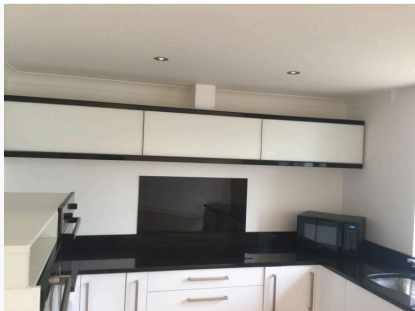
Ref #9

Ref	Name	Description	Condition	Additional Comments
9.1	Flooring	Solid oak floorboards	<p>Many of the floorboards are slightly moving apart and lots of gaps are visible throughout; Lightly scuffed and scratched on entry; Flooring appears to be slightly raising in front of the washing machine; Further light scuffs to the centre; One of the floorboard is cracked to the middle in front of the 3 x large drawers;</p> <p>There is an additional small drilled hole to the far left corner of the floor; Needs Maintenance - Tenant</p>

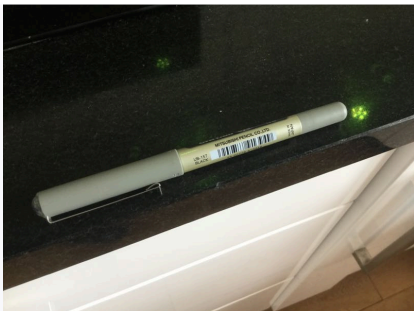
Ref # 9.8

9.8 Kitchen » Worktop	Comment	There are 2 x 1/2 chips visible to the front edge of the granite worktop, opposite the hob area;
9.17 Kitchen » Hob	Comment	There are 2 x 1cm chips in the glazed surface to the front left hand side corner of the hob;
15.5 Schedule of Condition » Curtains / blinds	Needs Cleaning	Dust present to the top edges of the blind in the living room; Further cleaning is required in this area only;
15.10 Schedule of Condition » Fridge	Needs Cleaning	A final wipe is required as some light food residue remains;

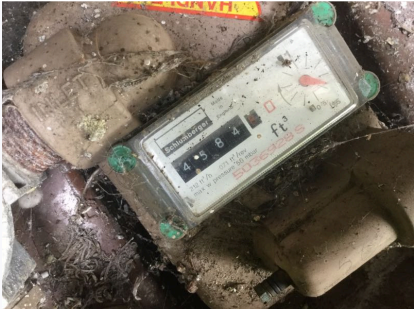
Ref # 11.2

Ref	Name	Description	Condition	Additional Comments
11.1	Electric Meter	Cabinet near flat door; Serial Number: S95111071	24872;	
11.2	Gas Meter	Front Of building; First hatch to the left of the building main doors; Covered by a large bush; Serial Number: 5036928S	4584;	
11.3	Water Meter	2 X hatches present to the front left of the building main doors; Meter located in the right hatch; Serial Number: 16MU060785	Appears to read 0028 but very difficult to read as the top cover is obscuring the display;

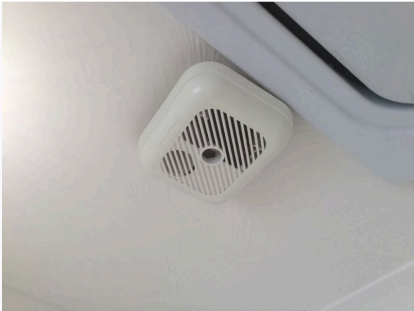
Ref # 13.2

Ref	Name	Condition	Additional Comments
13.1	Hallway	Tested and working;	
13.2	Hallway	Not in use;
